• **Timber Frame Withstands Fire**

But Timber Hangar Frame Stands Up

T. K. May
Director of Technical Service
West Coast Lumbermen's Association
Portland, Oregon

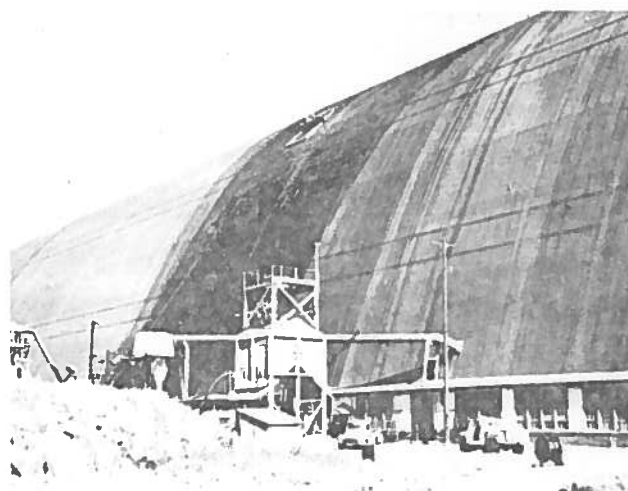
Roofing material burned when residuals in plywood manufacturing facilities, now occupying former World War II blimp hangar at Tillamook, Ore., burst into flames

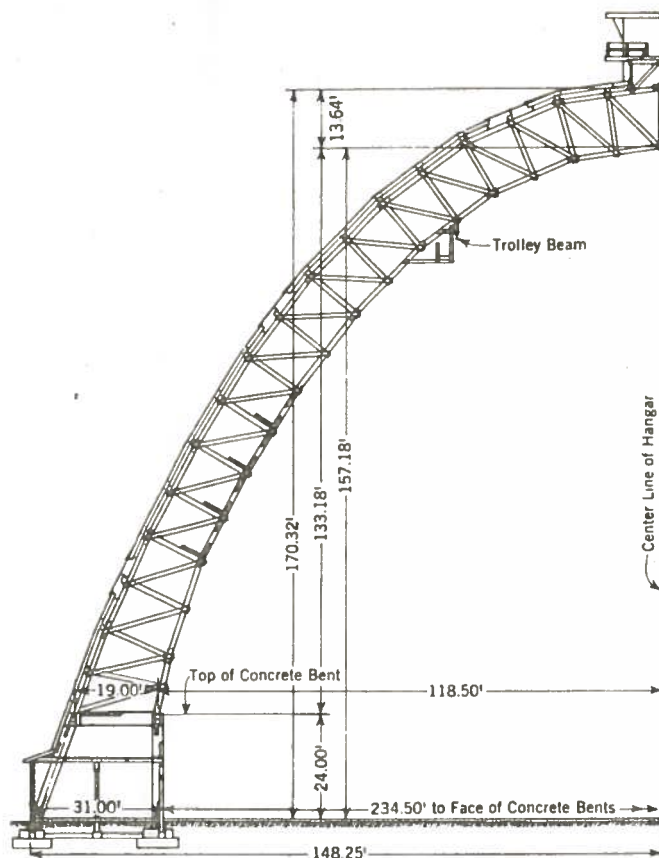
TYPICAL SECTION OF HANGAR

• **Design details**—The arch ribs are truss type, spaced on 20-ft centers, and supported on reinforced concrete abutment bents 24 ft in height. The trussed ribs are 18½ ft deep. Chords vary from two 3x12 to two 4x12 pieces and the web verticals from one 4x8 to one 6x18 piece while the web diagonals consist of two 3x8's.
